RESULTS OF THE  
SECOND UNITED STATES  
MANNED ORBITAL SPACE FLIGHT

MAY 24, 1962

NASA SP-6

PROJECT MERCURY

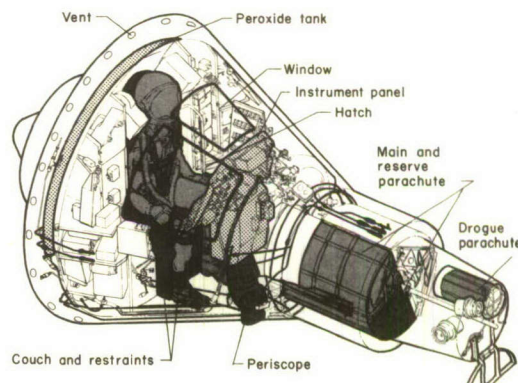
FIGURE 1-1.—Mercury spacecraft systems.

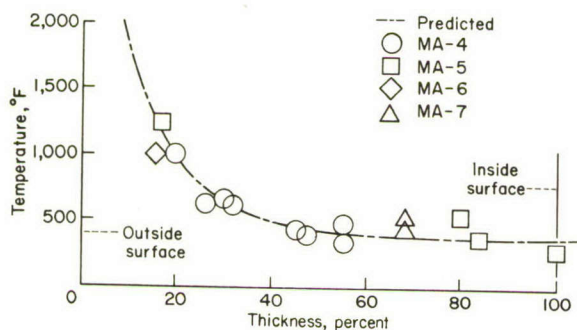
FIGURE 1-2.—Maximum ablation-shield temperatures.

Two temperature measurements were made in the ablation shield, one at the center and the other approximately 27 inches from the center. The maximum recorded values are graphically shown and compared with previously obtained orbital reentry values in figure 1-2. The magnitudes of these temperatures, as well as the ablation-shield weight loss during reentry, are comparable with previous flights. The supporting structure behind the ablation shield was found to be in excellent condition following the flight. A more complete temperature survey of points around the afterbody than on previous flights was conducted for MA-7. This survey was made possible by the addition of a low-level commutator circuit. The data, which are shown in figure 1-3, were within expected ranges, and the integrity of the structure was not affected by the thermal loads experienced.

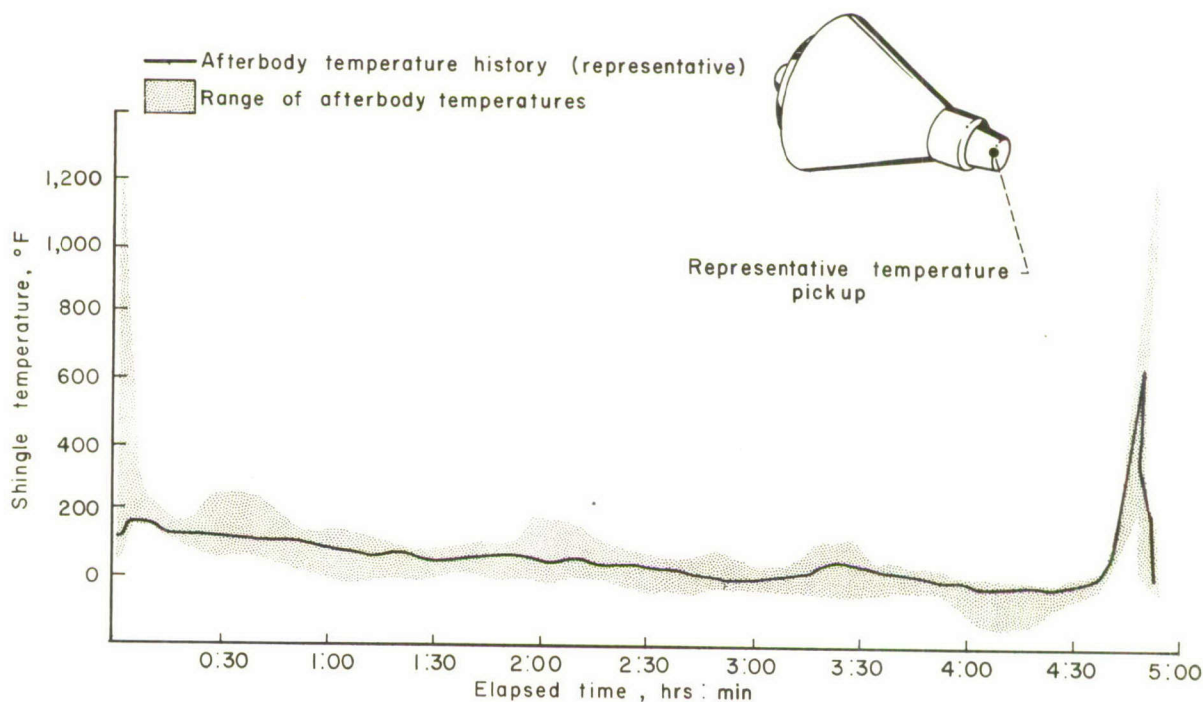
FIGURE 1-3.—Afterbody temperature from low-level commutator circuit.

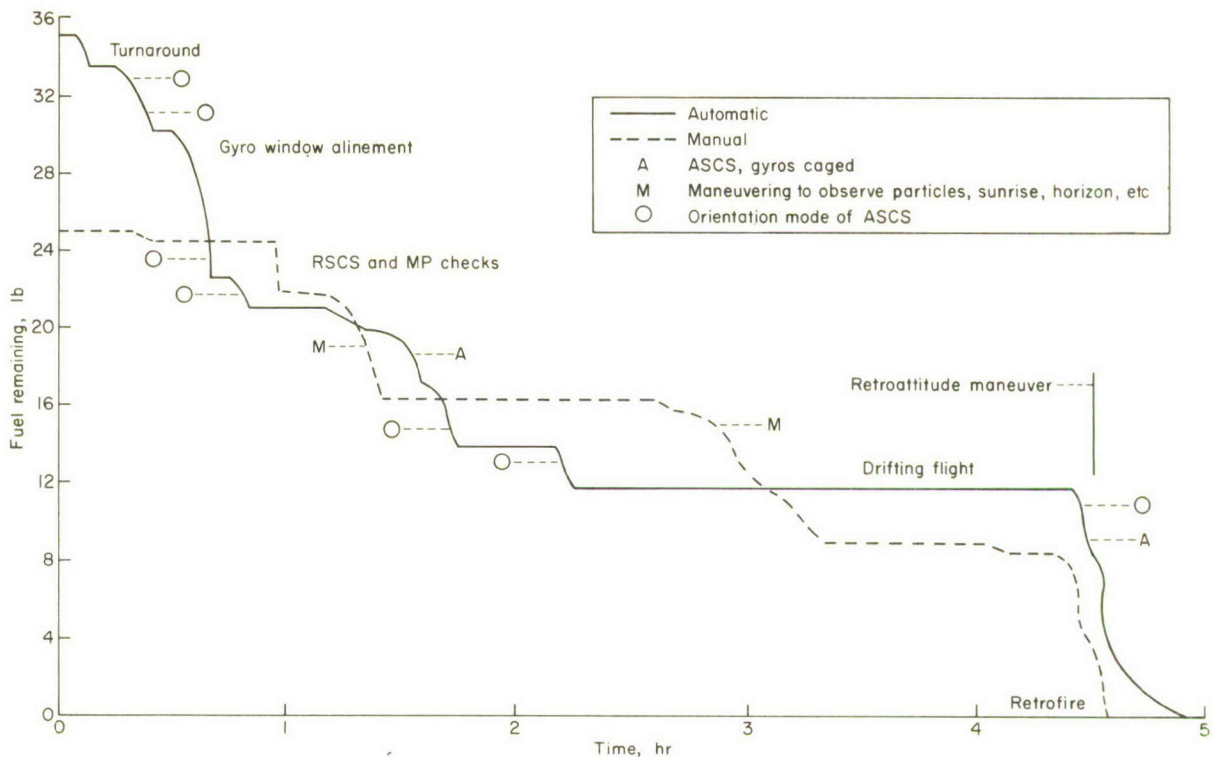
FIGURE 1-7.—Fuel usage rates.

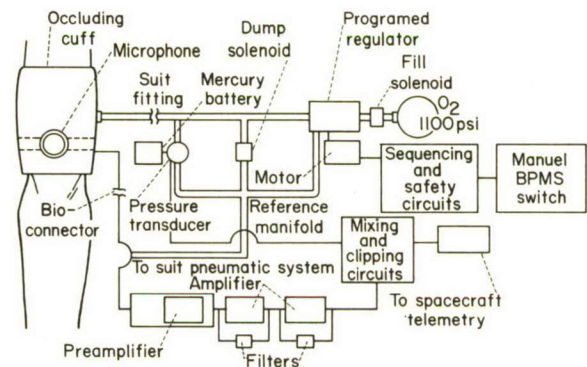
FIGURE 1-8.—Semiautomatic blood-pressure measuring system.

The data transmitted from the blood-pressure measuring system were questionable at times during the flight, primarily because of the magnitude of the data and the intermittency with which it was received. The intermittent signals were found to have resulted from a broken cable in the microphone pickup, shown in figure 1-8. This malfunction, however, could not have affected the magnitude of the transmitted information, since an intermittent short either sends valid signals or none at all. The BPMS was thoroughly checked during postflight tests in the laboratory using actual flight hardware, with the exception of the microphone and cuff. Tests of the controller unit and amplifier were also conducted, and no component failure or damage in the BPMS has been detected to date. However, a number of uncertainties regarding the calibration and operation of the BPMS still

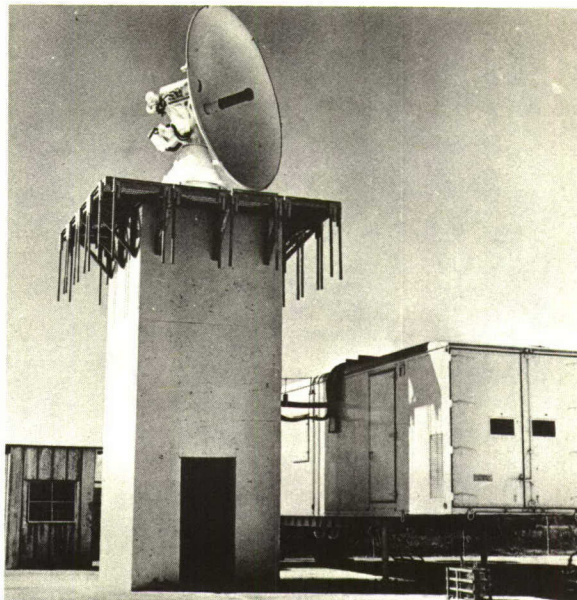
FIGURE 2-3.—Verlort radar installation at Guaymas, Mexico.

Two principal types of precision tracking radars are used in the Mercury ground range to track the spacecraft: the AN/FPS-16 and Verlort radars. The AN/FPS-16, shown in figure 2-2, is a precision C-band tracking radar with a 12-foot dish. It operates on a frequency of 5,500 to 5,900 mc and has a beam width of approximately  $1.2^\circ$ . It is the most accurate of our tracking devices. The S-band, or Verlort, radar, shown in figure 2-3, is a very long-range tracking radar with a 10-foot dish. It operates on a frequency of 2,800 to 3,000 mc and has a beam width of approximately  $2.5^\circ$ . The redundancy provided by both of these radar systems supplies the computers with sufficient data to determine the orbit, should one of the spacecraft beacons fail. The active acquisition aid has a quad-helix antenna, which is shown in figure 2-4. It has a broad beam width of  $20^\circ$ , operates on telemetry frequencies (215 to 265

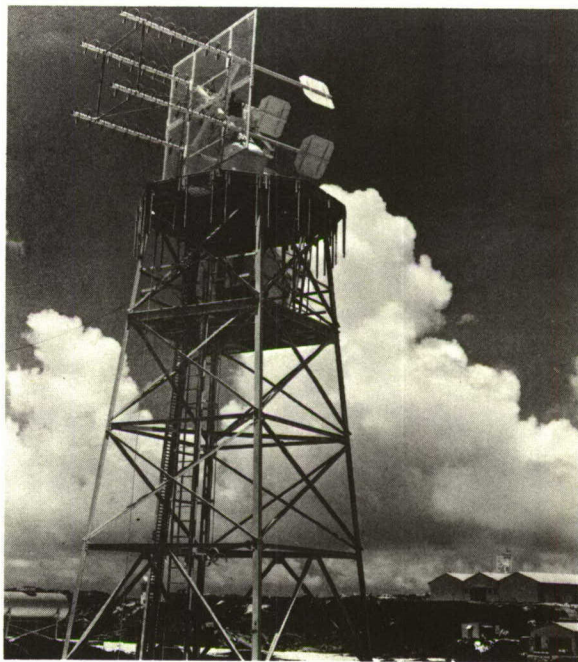
FIGURE 2-4.—Acquisition aid quad-helix antenna at Bermuda.

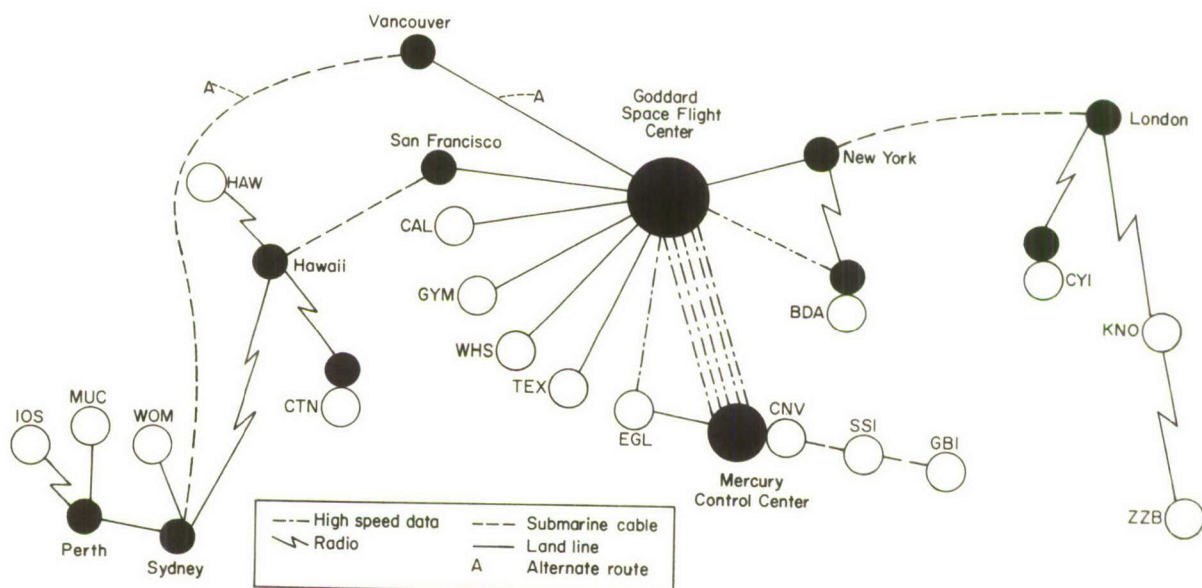
FIGURE 2-8.—Data circuits for Project Mercury.

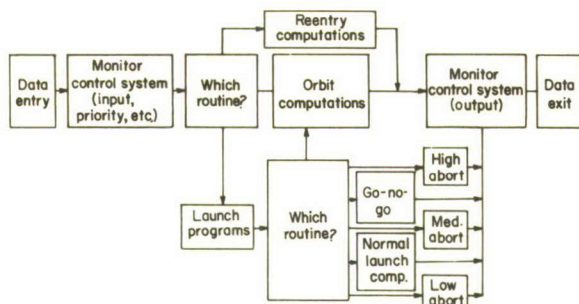
FIGURE 2-10.—Real-time monitor control system.

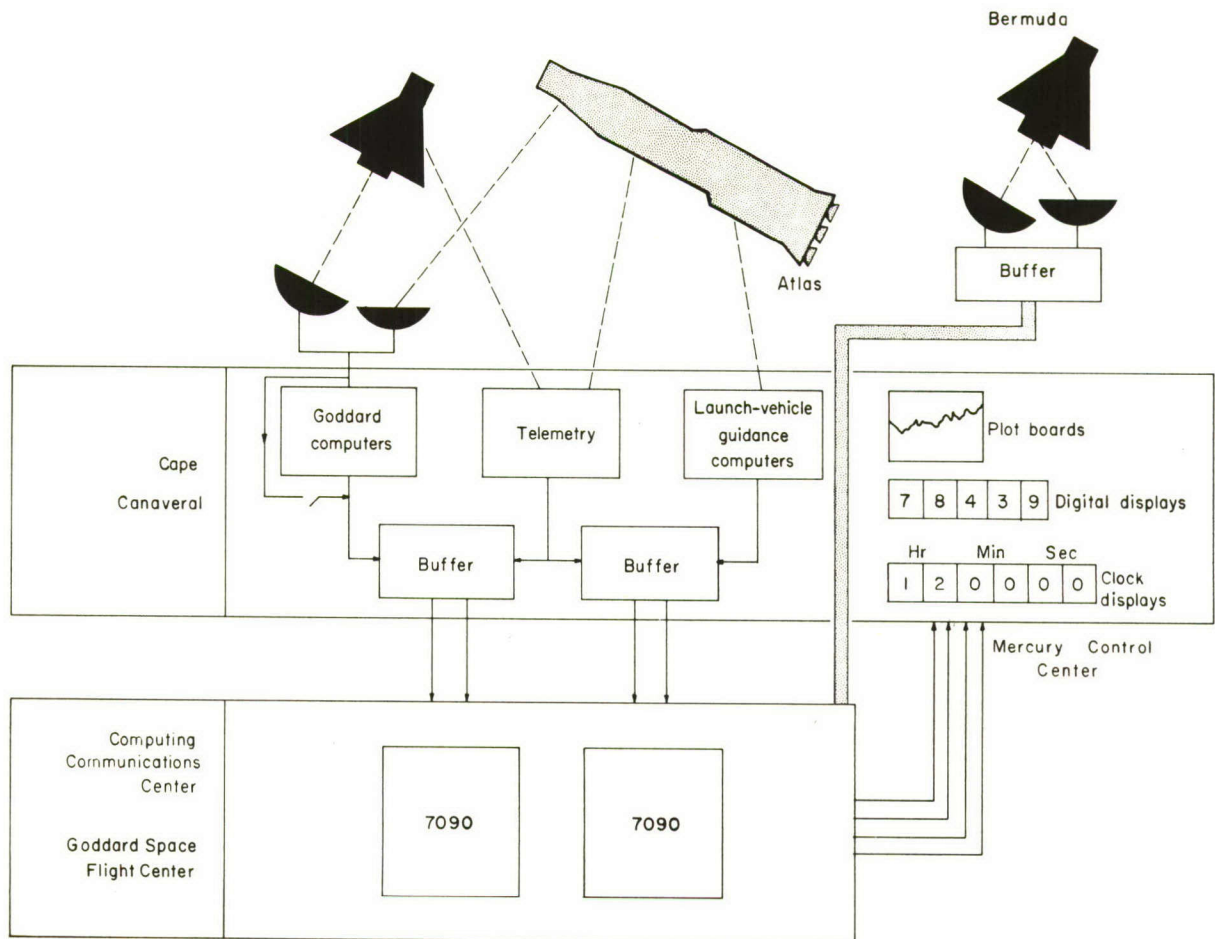
FIGURE 2-11.—Computer data sources during launch.

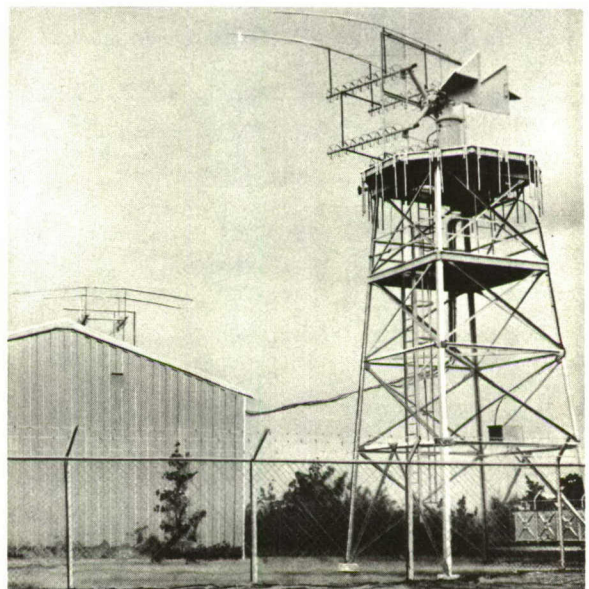
FIGURE 2-12.—Telemetry antenna installation at Kano, Nigeria.

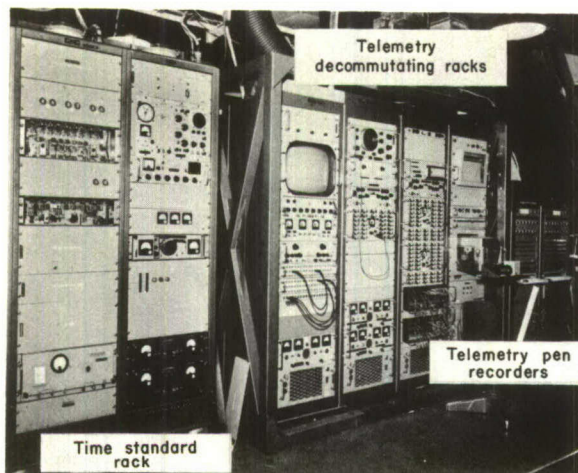
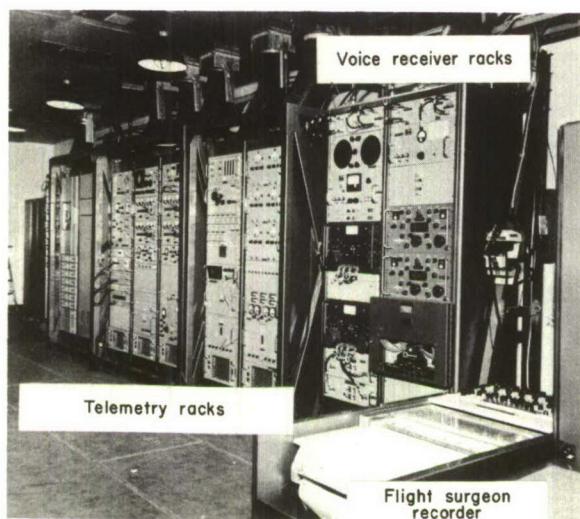
FIGURE 2-13.—Typical telemetry receiving equipment.

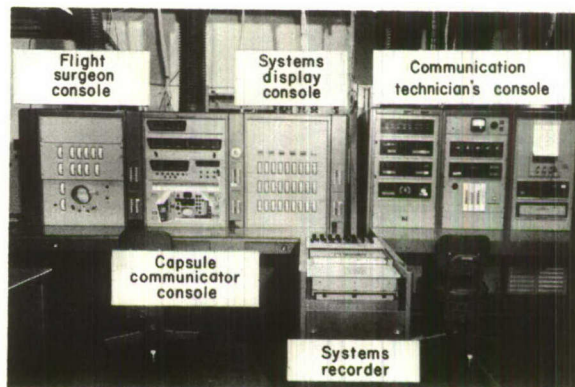
FIGURE 2-14.—Typical display consoles at remote stations.

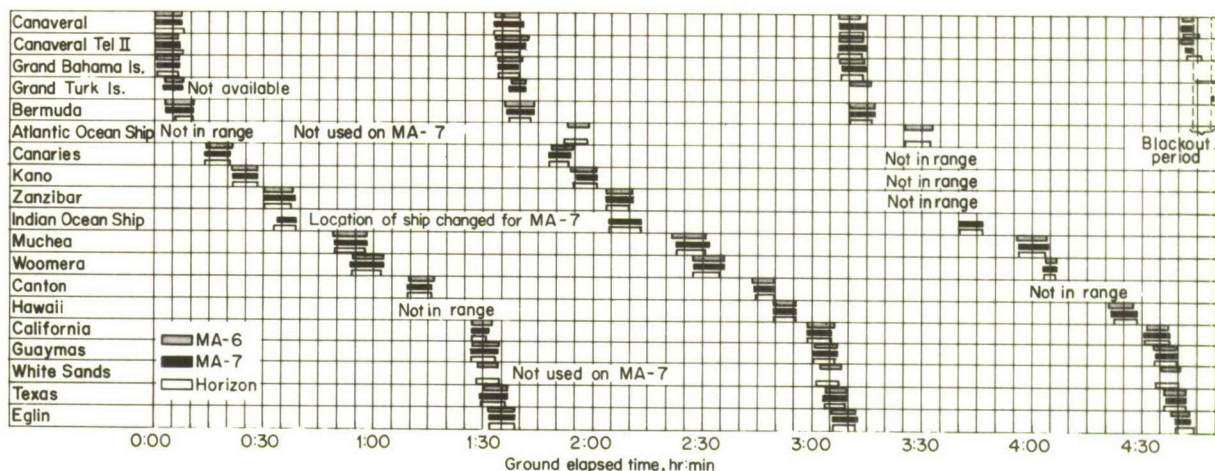
FIGURE 2-15.—Comparison of telemetry coverage times for MA-6 and MA-7.

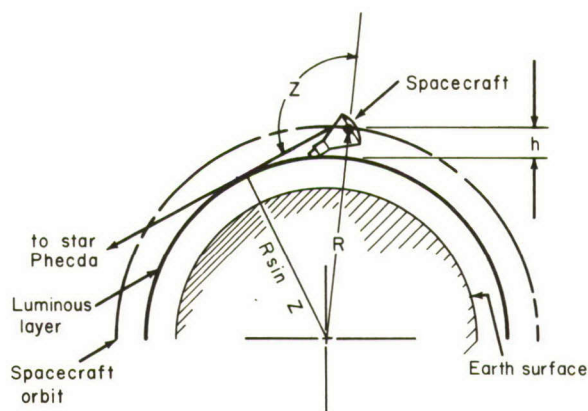
FIGURE 4-1.—Parameters used to calculate height of layer.

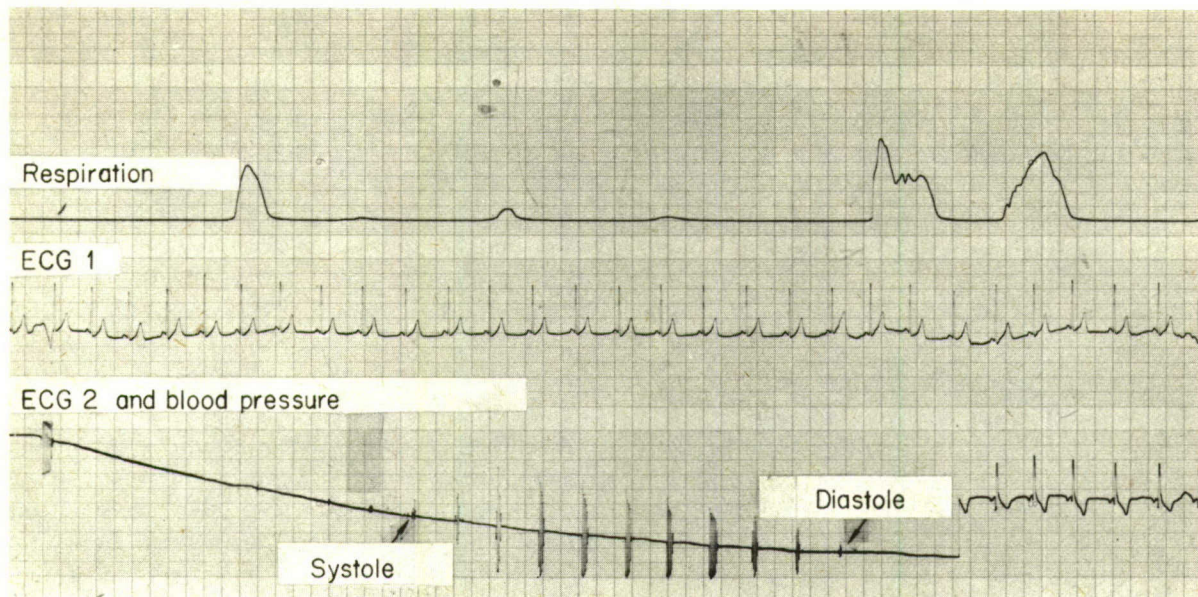
FIGURE 5-4.—Bioinstrumentation from blockhouse records (T-68 minutes).

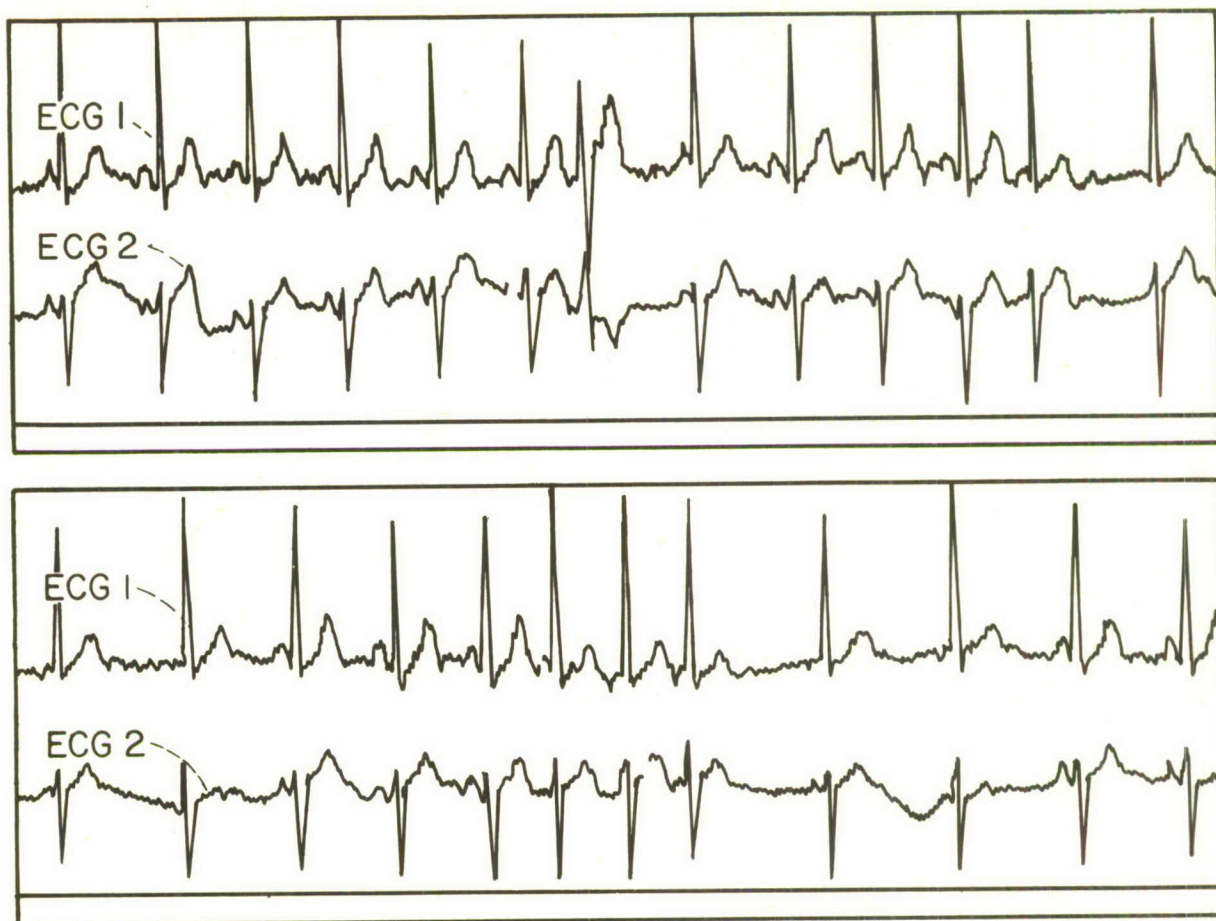
FIGURE 5-7.—Onboard physiological reentry data.
